PHOTOGRAPHIC SURVEY OF THE LDEF MISSION

NASA Special Publication 531

Robert L. O'Neal

Langley Research Center
Hampton, Virginia 23681-0001

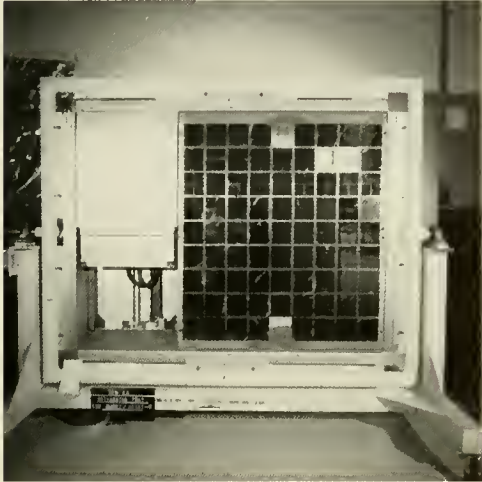
Figure 405 (Postflight). The capture cells have degraded and only 11 of the 77 metallized Mylar covers survived. There is a brown stain on the tray, the capture cell mounting, and the calorimeter mounting plates. The green tint on the right side of the experiment is a reflection of lights from an adjacent room. The canister for experiment S1002 is closed.

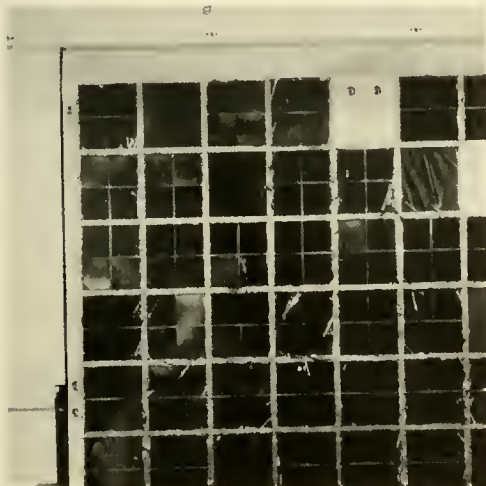
Figure 406 (Postflight). This photograph is of the upper left one-fourth of experiment AO187-2. Two capture cell covers are intact. The remains of the others are curled tightly and hanging from one edge. There is considerable discoloration on the upper mounting frame and on the calorimeter.

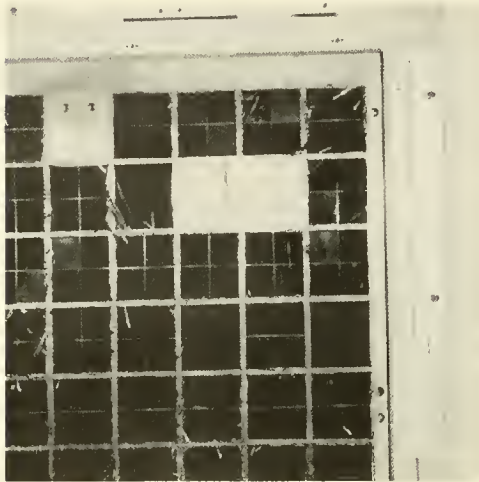
Figure 407 (Postflight). This photograph is of the upper right one-fourth of experiment AO187-2. Three capture cell covers are intact. The remains of the others are curled tightly and are hanging from one edge. There is considerable discoloration on the upper and right sides of the mounting frame and on the calorimeter.

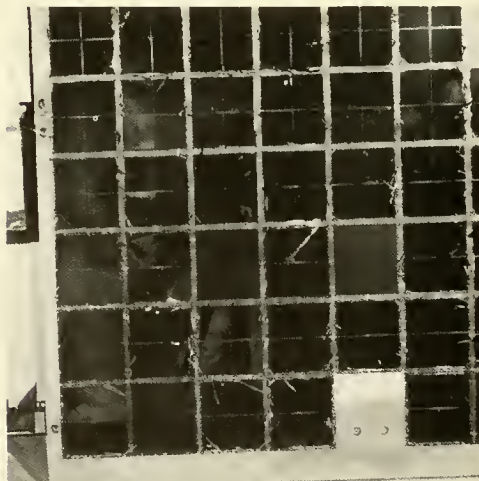
Figure 408 (Postflight). This photograph is of the lower left one-fourth of experiment AO187-2. Four capture cell covers are intact. The remains of the others are curled tightly and are hanging from one edge. There is considerable discoloration on the left and lower sides of the mounting frame and on the calorimeter. Note the reflection of the photographer.

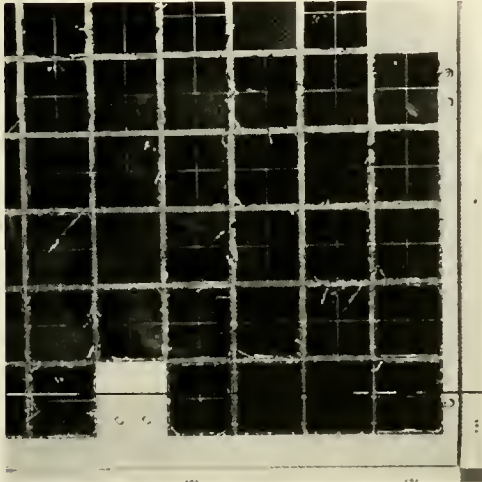
Figure 409 (Postflight). This photograph is of the lower right one-fourth of experiment AO187-2. Four capture cell covers are intact. The remains of the others are curled tightly and are hanging from one edge. There is considerable discoloration on the lower and right sides of the mounting frame and on the calorimeter. Note the reflection of the photographer.

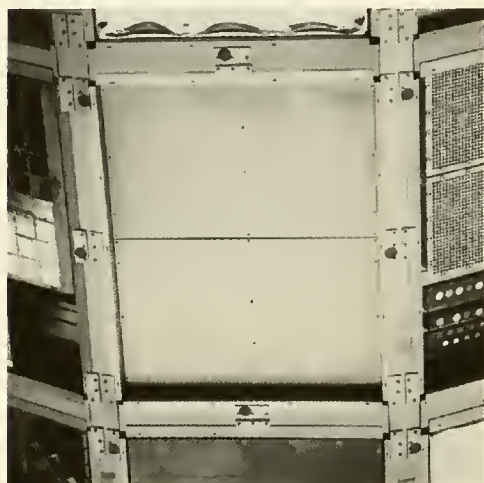
Figure 410 (In Flight). The greenish-gray and pink tints on the two debris panels are by-products of the chromic anodize coating process and are not attributed to contamination or exposure to the space environment. Discolorations are visible along some edges of the panels, thus indicating improper handling and cleaning after panel assembly.

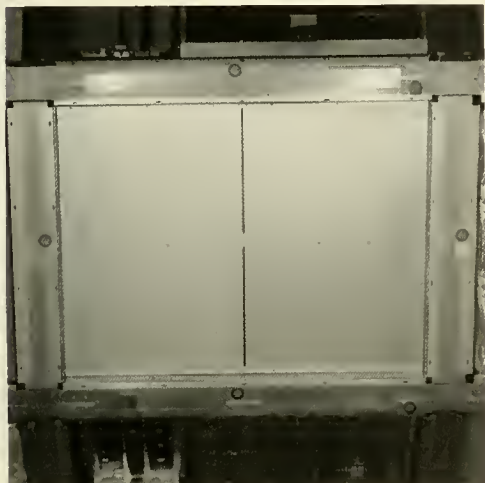
Figure 411
Photo No.: KSC-390C-832.03
Dup. Neg. No.: L90-13350
LISAR No.: EL-1994-00172
Photo Credit: KSC
Photo Date: 2/7/90
Location: KSC SAEF II
Subject: Postflight Survey of Tray E4

Figure 411 (Postflight). The greenish-gray and pink tints on the two debris panels are by-products of the chromic anodize coating process and are not attributed to contamination or exposure to the space environment. The fingerprints along the bottom edge of the panels that were observed in the in-flight photograph are still visible. The light band along the sides and across the bottom of the tray is caused by light reflected from the tray sidewalls.

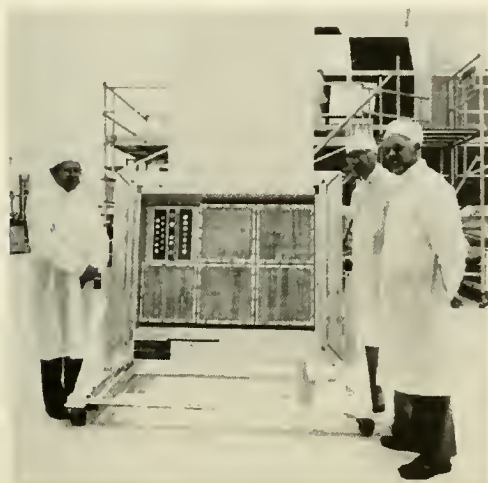
Figure 412
Photo No.: KSC-384C-255.06
Dup. Neg. No.: L89-4387
LISAR No.: EL-1994-00372
Photo Credit: KSC
Photo Date: 1/18/90
Location: KSC SAEF II
Subject: Preflight Survey of Tray E5

Figure 412 (Preflight). The test specimens were typically placed on fiberglass-epoxy retainer strip assemblies and mounted in the tray. Five of the six sections of the tray were covered by a 1/8-in-thick anodized aluminum sun screen with openings that allowed 56-percent transmission over the central region. The remaining one-sixth was open to the space environment.

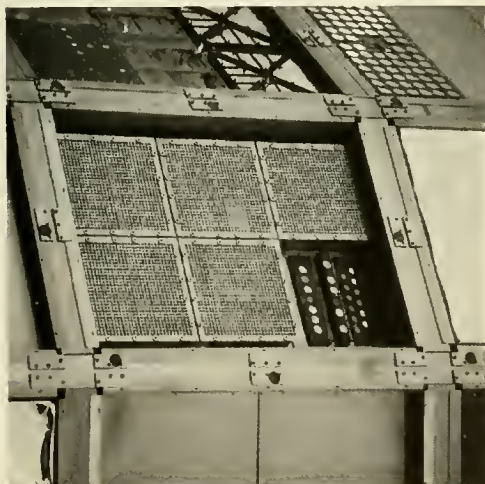
Figure 413
Photo No.: S32-77-050
Dup. Neg. No.: L90-10413
LISAR No.: EL-1994-00679
Photo Credit: JSC
Photo Date: 1/12/90
Location: KSC SAEF II
Subject: In-Flight Survey of Tray E5

Figure 413 (In Flight). In this photograph, the experiment hardware appears to be without physical damage. The blue is due to lighting. The exposed experiment test specimens and the fiberglass-epoxy mountings appear to have survived the mission. The colors of the fiberglass-epoxy mounting strip have changed from the typical greenish gray to a slate gray and the colors of the test specimen appear to be much darker than in the prelaunch photograph.

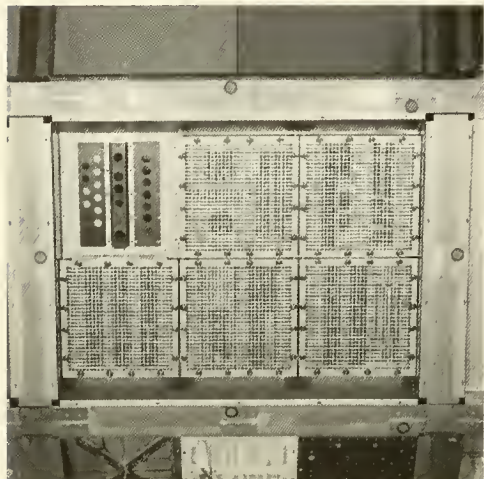
Figure 414
Photo No.: KSC-390C-1035.05
Dup. Neg. No.: L90-13450
LISAR No.: EL-1994-00183
Photo Credit: KSC
Photo Date: 2/9/90
Location: KSC SAEF II
Subject: Postflight Survey of Tray E5

Figure 414 (Postflight). The experiment hardware appears to be without physical damage.

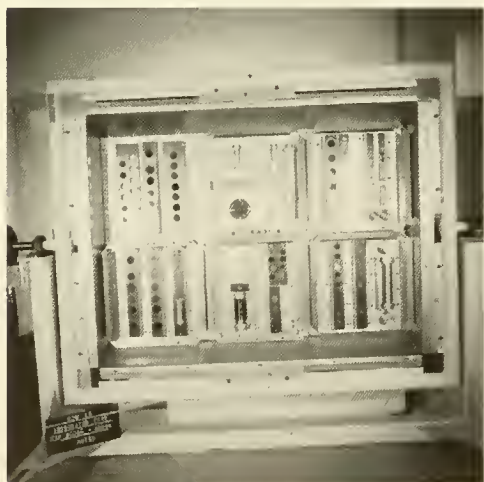
Figure 415
Photo No.: KSC-390C-2114.03
Dup. Neg. No.: L91-10508
LISAR No.: EL-1994-00491
Photo Credit: KSC
Photo Date: 3/20/90
Location: KSC SAEF II
Subject: Postflight Survey of Tray E5

Figure 415 (Postflight). This photograph was taken after the experiment tray was removed from the LDEF and the sun screens were removed. The experiment hardware appears to be without physical damage. The colors of the fiberglass-epoxy mounting strip vary from the typical greenish gray to a slate gray in proportion to their exposure. The red material on top of the aluminum support structure are silicon rubber gaskets between the sun screen and the structure. The gasket material that is missing adhered to the sun screens.

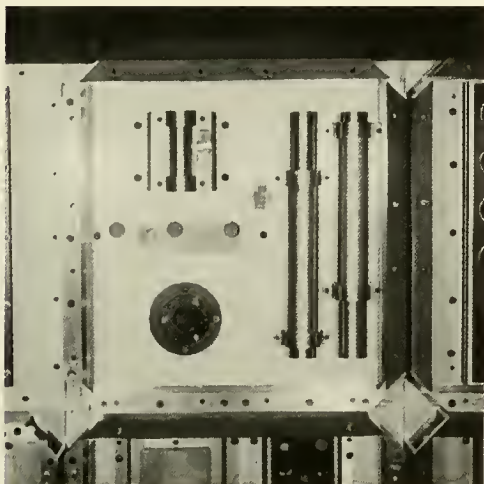
Figure 416 (Postflight). This photograph is of the upper center one-sixth of the tray. The experiment hardware is without physical damage.

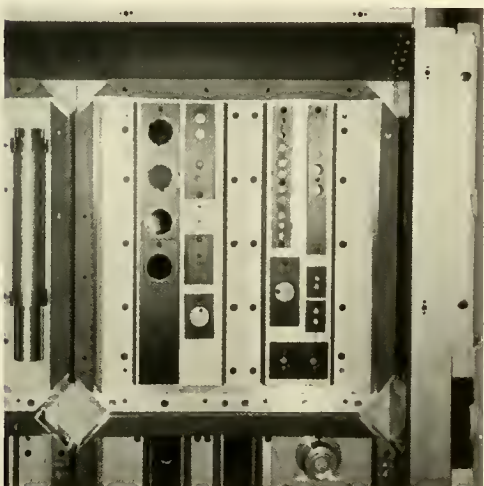
Figure 417 (Postflight). This photograph is of the upper right one-sixth of the tray. The experiment hardware is without physical damage.

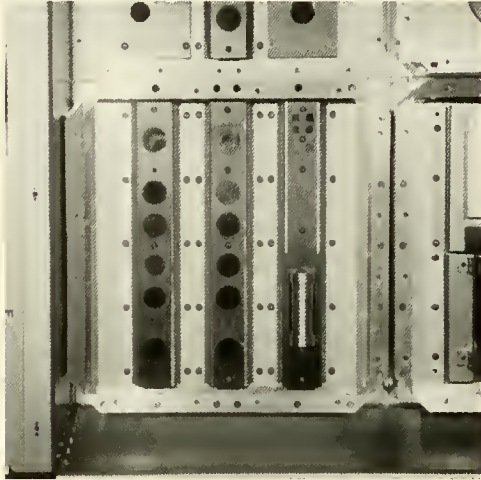
Figure 418 (Postflight). This photograph is of the lower left one-sixth of the tray. The experiment hardware is without physical damage.

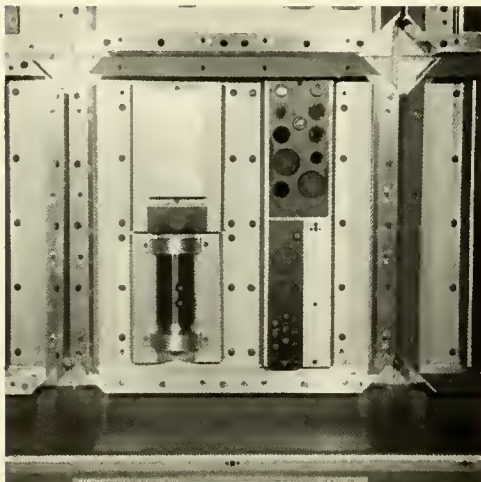
Figure 419 (Postflight). This photograph is of the lower center one-sixth of the tray. The experiment hardware is without physical damage.

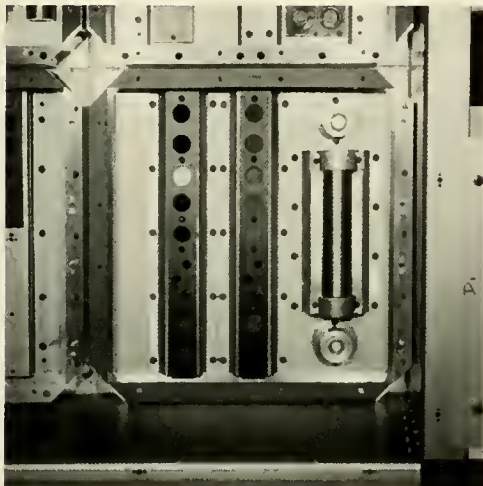
Figure 420 (Postflight). This photograph is of the lower right one-sixth of the tray. The experiment hardware is without physical damage.

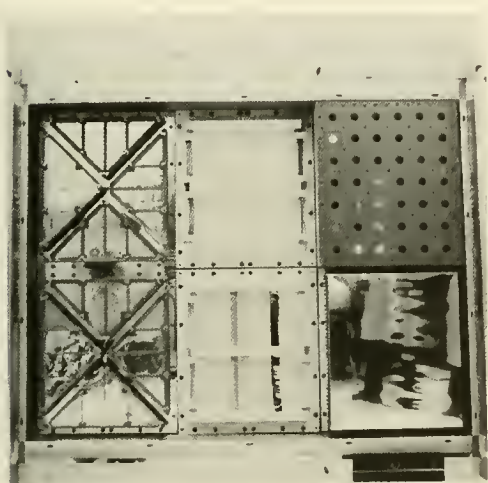
Figure 421
Photo No.: KSC-384C-193.10
Dup. Neg. No.: L84-7068
LISAR No.: EL-1994-00356
Photo Credit: KSC
Photo Date: 1/12/84
Location: KSC SAEF II
Subject: Preflight Survey of Tray E6

Figure 421 (Preflight). In this photograph, experiment AO023, described in figure 230, is shown in the left one-third section. Experiment S1006 occupies the center one-third section. Experiment M0002-2 is in the lower right section. Experiment S1003 is in the top right section of the 3-in-deep tray. Discolorations are visible on the die-cast frames of experiment AO023. Light reflections cause areas of the thin sensor films of experiment AO023 to appear dark.

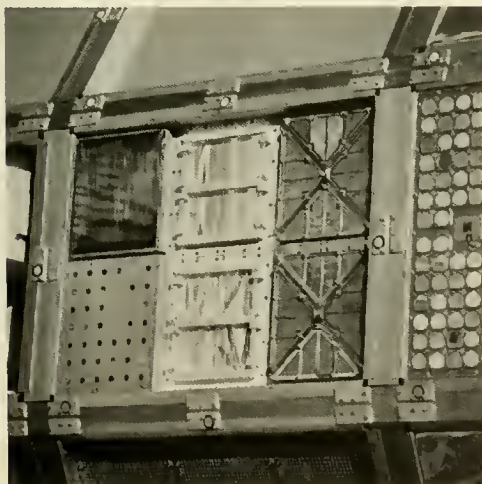
Figure 422
Photo No.: S32-82-006
Dup. Neg. No.: L90-10454
LISAR No.: EL-1994-00024
Photo Credit: JSC
Photo Date: 1/12/90
Location: KSC SAEF II
Subject: In-Flight Survey of Tray E6

Figure 422 (In Flight). The tray clamp dot varies from preflight white at the top to dark brown at the bottom, which is an indication of the transition from leading to trailing side. There are reflections in the foil of the upper sensor of experiment AO023. Low lighting prevents details from being visible in this experiment. The ripples in the Kapton cover foil of experiment M0002-2 that were observed in the prelaunch photograph also appear in the in-flight photographs, but they are at a lower frequency of repetition. The source of discolorations on the aluminized Kapton cover, which appear to be vertical scratches, is unknown. The hardware for experiment S1003 appears to be intact with little or no damage to experiment samples. Many material samples in experiment S1006 have been severely degraded and the base plate is discolored.

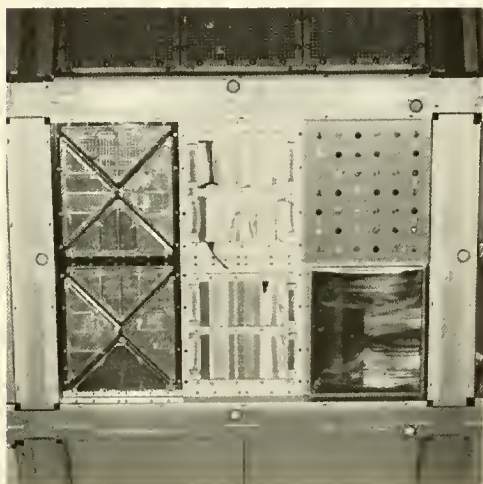
Figure 423 (Postflight). Experiment AO023 has no visible physical damage, but the die-cast frames have discolorations. The detector assemblies of experiment M0002-2 appear to be without physical damage. The source of the discolorations on the aluminized Kapton cover, which appear as horizontal scratches and vertical bands, is unknown. The hardware of experiment S1003 appears to be intact and experiment samples appear to have only minor changes. Many of the material samples in experiment S1006 seem to have severely degraded and the base plate is discolored.

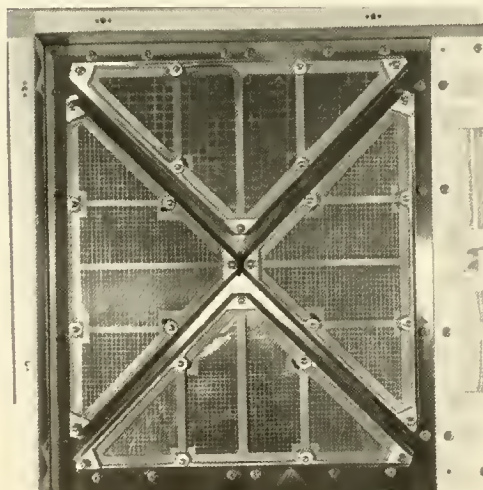
Figure 424 (Postflight). This photograph is of the upper left one-sixth of the tray. The hardware of experiment AO023 is intact. Light reflections are evident in the sensor foil surfaces. There is discoloration on the upper triangular die-cast mounting frame.

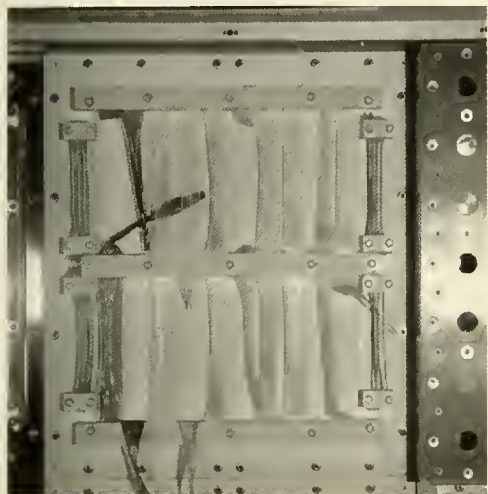
Figure 425
Photo No.: KSC-390C-1992.05
Dup. Neg. No.: L91-10539
LISAR No.: EL-1994-00414
Photo Credit: KSC
Photo Date: 3/15/90
Location: KSC SAEF II
Subject: Postflight Detail of Upper Center of Tray E6

Figure 425 (Postflight). This photograph is of the upper center one-sixth of the tray. The thin-film polymeric material samples in experiment S1006 have been severely degraded. All 26 of the unreinforced thin-film samples have curled edges. Twelve samples appear to have failed in tension and a significant portion of the two aluminized polymer samples appears to be missing. The IITRI S13G-LO white paint on the baseplate has a light tan discoloration.

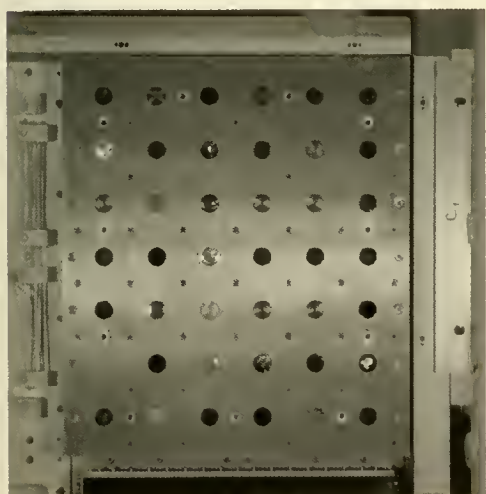
Figure 426
Photo No.: KSC-390C-1992.06
Dup. Neg. No.: L91-10540
LISAR No.: EL-1994-00415
Photo Credit: KSC
Photo Date: 3/15/90
Location: KSC SAEF II
Subject: Postflight Detail of Upper Right of Tray E6

Figure 426 (Postflight). This photograph is of the upper right one-sixth of the tray. The hardware of experiment S1003 is without physical damage and experiment samples have only minor changes. The IITRI S13G-LO white paint sample located second to the right of the lower left corner has changed to light brown and the material sample located second above the lower right corner is partially missing. Other material samples appear in prelaunch condition.

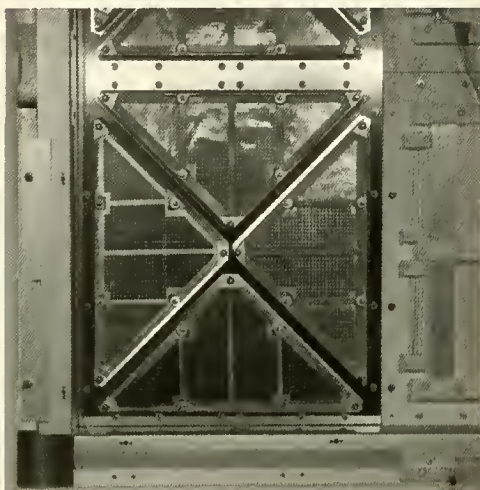
Figure 427 (Postflight). This photograph is of the lower left one-sixth of the tray. The hardware of experiment AO023 is intact. Light reflections are evident in the sensor foil surfaces.

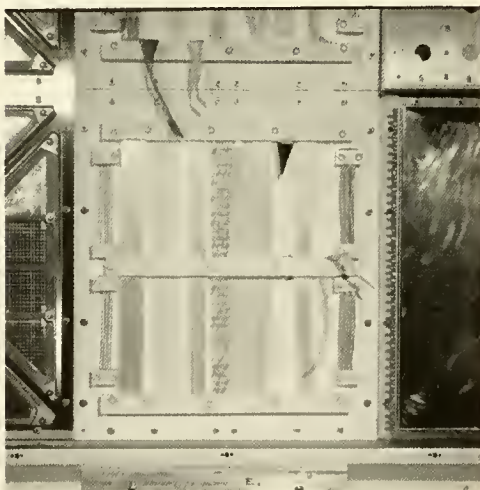
Figure 428 (Postflight). This photograph is of the lower center one-sixth of the tray. The test specimens of experiment S1006 have suffered some degradation. The reinforced thin-film polymer samples are discolored, but they have survived the mission intact. The IITRI S13G-LO white paint on the baseplate has a light tan discoloration in areas that were not covered by experiment samples (with evidence that at least some of the discoloration occurred after sample failure).

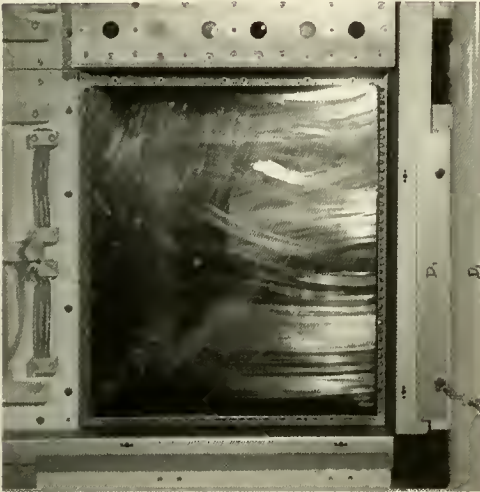
Figure 429 (Postflight). This photograph is of the lower right one-sixth of the tray. Photographic light reflections in the surface are apparent. The experiment appears to have no physical damage from the extended space exposure. The source of discolorations on the aluminized Kapton cover, which appear as horizontal scratches and vertical shadows, is unknown.

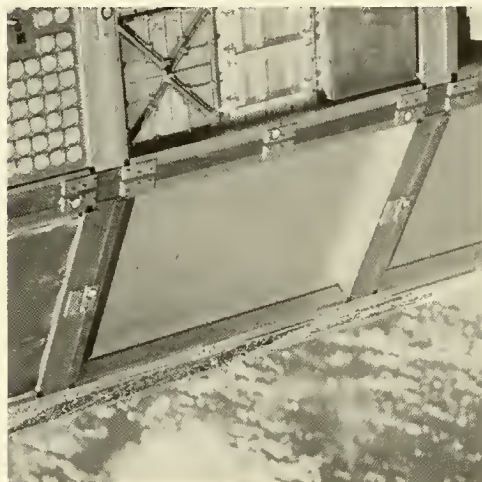
Figure 430 (In Flight). The discolorations on the lower tray sidewall appear to be fingerprints from handling during experiment assembly. A portion of the pink and greenish-gray tint on the two debris panels are a by-product of the chromic anodize coating process; however, a part of the intensity can be attributed to reflections of the blue sky. The horizontal streaks on the left debris panel and the vertical streaks on the right debris panel are also by-products of chromic anodizing that have been enhanced significantly by the blue reflection.

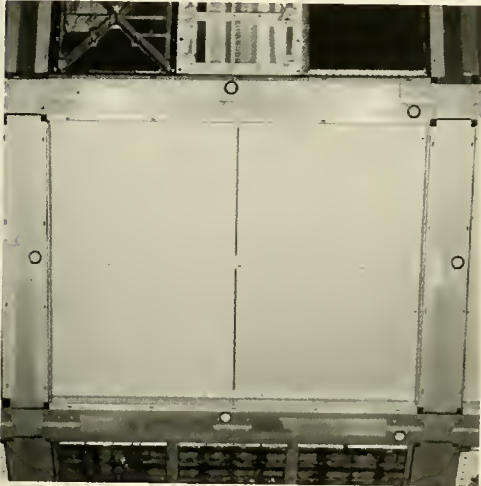
Figure 431
Photo No.: KSC-390C-1032.03
Dup. Neg. No.: L90-13425
LISAR No.: EL-1994-00148
Photo Credit: KSC
Photo Date: 2/9/90
Location: KSC SAEF II
Subject: Postflight Survey of Tray E7

Figure 431 (Postflight). The pink and greenish-gray tints on the two debris panels are by-products of the chromic anodize coating process and are not attributed to contamination or exposure to the space environment. The streaks on the debris panels that were noted in the in-flight photographs are almost invisible because the reflection of the sky is not present. The light band along the sides and across the bottom of the panels is caused by light reflecting from the tray sidewalls.

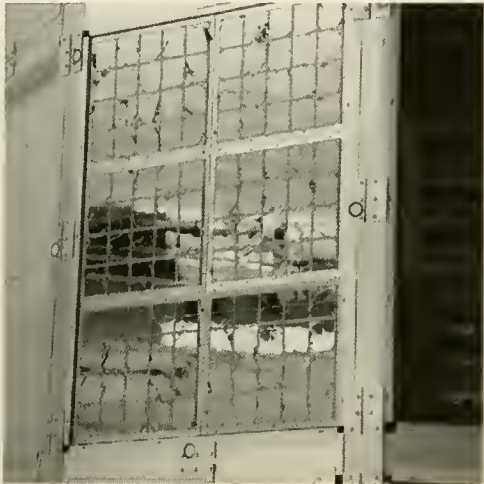
Figure 433
Photo No.: S32-76-016
Dup. Neg. No.: L90-10378
LISAR No.: EL-1994-00663
Photo Credit: JSC
Photo Date: 1/12/90
Location: In Flight
Subject: In-Flight Survey of Tray E8

Figure 433 (In Flight). The RMS arm of the Shuttle is reflected in the surface of the exposed germanium detector plates. The experiment has severely degraded. The metallic-coated Mylar film covers have failed on each of the capture cells and curled tightly into conical shapes.

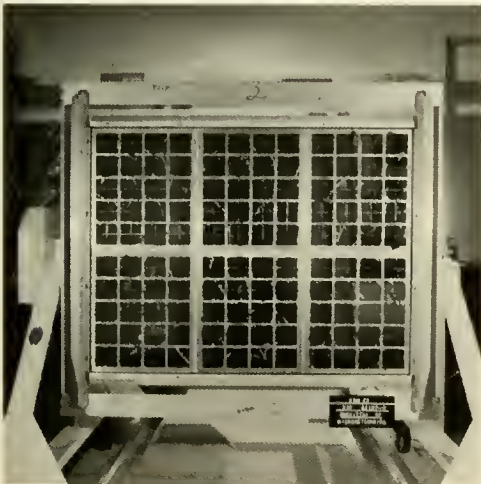
Figure 434
Photo No.: KSC-390C-1767.02
Dup. Neg. No.: L91-10614
LISAR No.: EL-1994-00267
Photo Credit: KSC
Photo Date: 3/90/90
Location: KSC SAEF II
Subject: Postflight Survey of Tray E8

Figure 434 (Postflight). The metallic-coated thin Mylar film has been lost on each of the capture cells. As the thin Mylar film failed, the material curled tightly into small conical shapes and is still attached to the edges of the aluminum mounting structure. The green tint on the germanium plate at the right edge of the experiment tray is a reflection from the lights in the high bay area of SAEF II. Dim reflections are visible on other sections of the experiment.

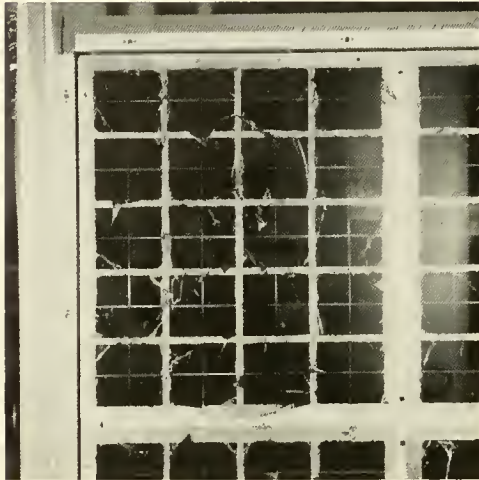
Figure 435 (Postflight). This photograph is of the upper left one-sixth of the tray. The metallic-coated thin Mylar film on all cells has failed and the remnants of the film are hanging loose. A reflection of the surrounding area in the surface of the germanium plates is visible.

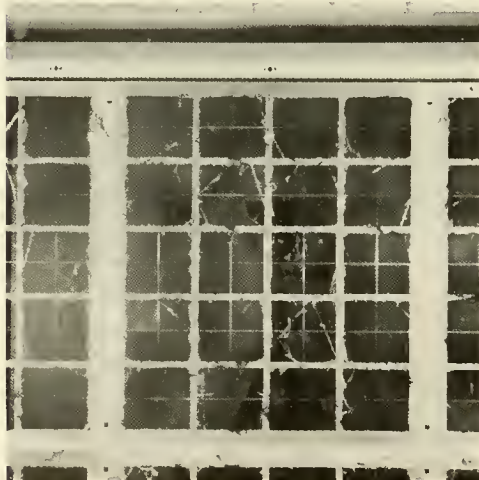
Figure 436 (Postflight). This photograph is of the upper center one-sixth of the tray. The metallic-coated thin Mylar film on all cells has failed and the remnants of the film are hanging loose. A reflection of the surrounding area in the surface of the germanium plates is visible.

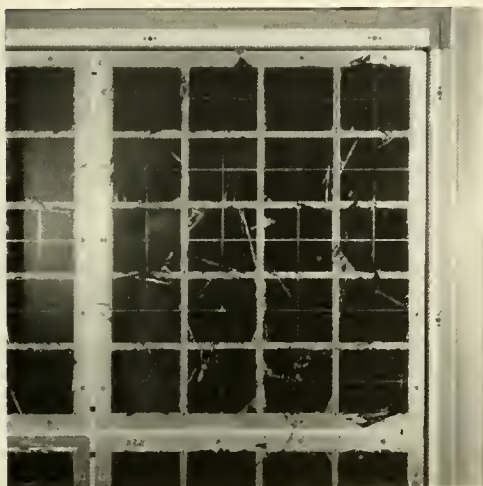
Figure 437 (Postflight). This photograph is of the upper right one-sixth of the tray. The metallic-coated thin Mylar film on all cells has failed and the remnants of the film are hanging loose. A reflection of the surrounding area in the surface of the germanium plates is visible.

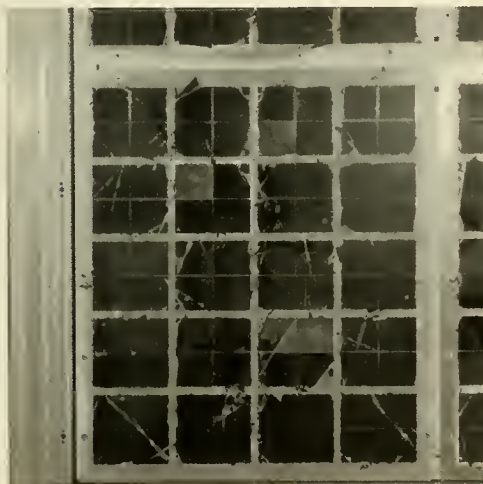
Figure 438 (Postflight). This photograph is of the lower left one-sixth of the tray. The metallic-coated thin Mylar film on all cells has failed and the remnants of the film are hanging loose. A reflection of the surrounding area in the surface of the germanium plates is visible.

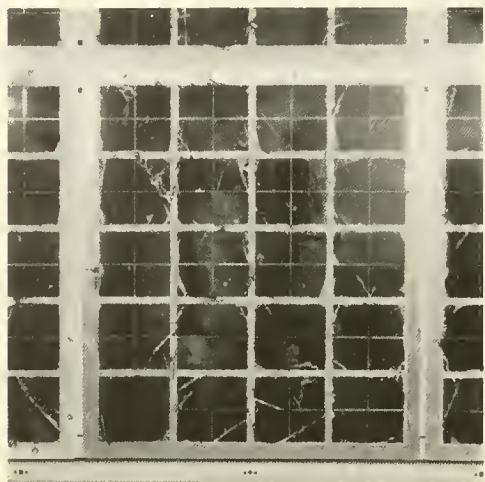
Figure 439 (Postflight). This photograph is of the lower center one-sixth of the tray. The metallic-coated thin Mylar film on all cells has failed and the remnants of the film are hanging loose. A reflection of the surrounding area in the surface of the germanium plates is visible.

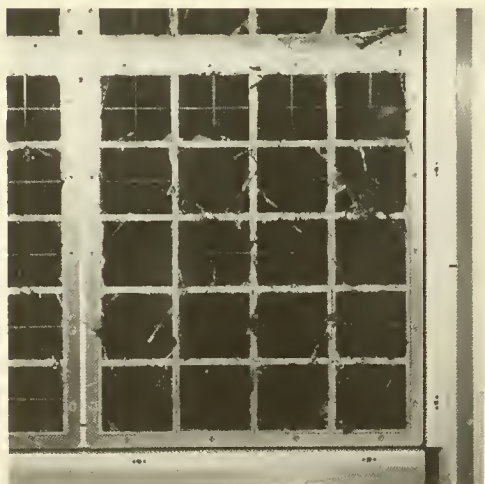
Figure 440 (Postflight). This photograph is of the lower right one-sixth of the tray. The metallic-coated thin Mylar film on all cells has failed and the remnants of the film are hanging loose. A reflection of the surrounding area in the surface of the germanium plates is visible.

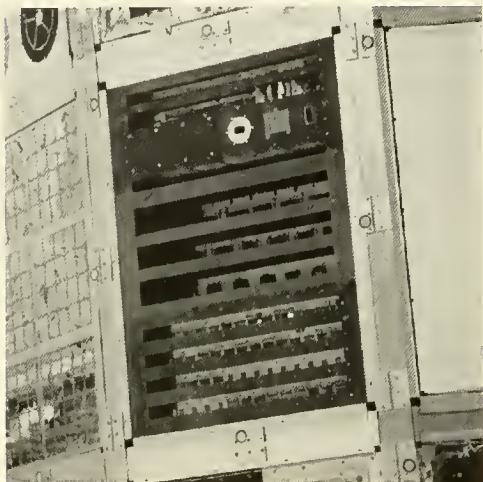
Figure 442
Photo No.: S32-78-090
Dup. Neg. No.: L90-10449
LISAR No.: EL-1994-00021
Photo Credit: JSC
Photo Date: 1/12/90
Location: In Flight
Subject: In-Flight Survey of Tray E9

Figure 442 (In Flight). The Chemglaze Z-306 black paint on the exposed surfaces has degraded, thus leaving the Chemglaze 9924 primer, which is reddish brown, clearly visible. The difference in the amount of paint remaining may be a function of initial paint thickness; the plate covering the center section was not painted at the same time as the other two plates. The experiment appears intact with little, if any damage.

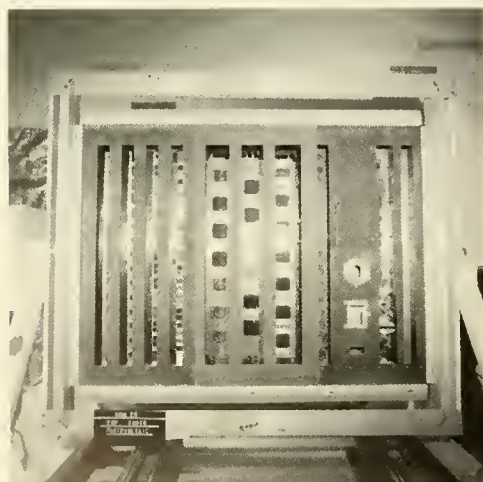
Figure 443
Photo No.: KSC-390C-1840.10
Dup. Neg. No.: L91-10676
LISAR No.: EL-1994-00279
Photo Credit: KSC
Photo Date: 3/12/90
Location: KSC SAEF II
Subject: Postflight Survey of Tray E9

Figure 443 (Postflight). The degradation of the Chemglaze Z-306 black paint on the exposed surfaces is evident by the amount of Chemglaze 9924 primer, which is reddish brown, that is visible. The difference in the amount of paint remaining may be a function of initial paint thickness; the plate covering the center section of the tray was not painted at the same time as the other two plates. The small gold-colored rectangular plate in the lower right section of the tray was fabricated from an aluminum alloy and coated with a clear anodize. A light brown discoloration is visible on the solar cell mounting plates and on areas of the aluminum base structure.

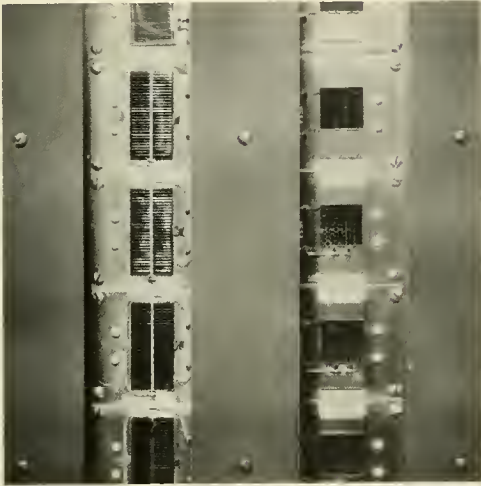
Figure 444 (Postflight). This close-up photograph is of the two left rows. No physical damage is evident.

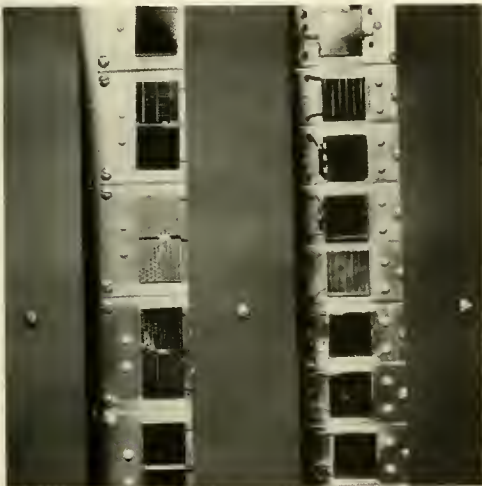
Figure 445 (Postflight). This close-up photograph is of the third and the fourth rows. No physical damage is evident.

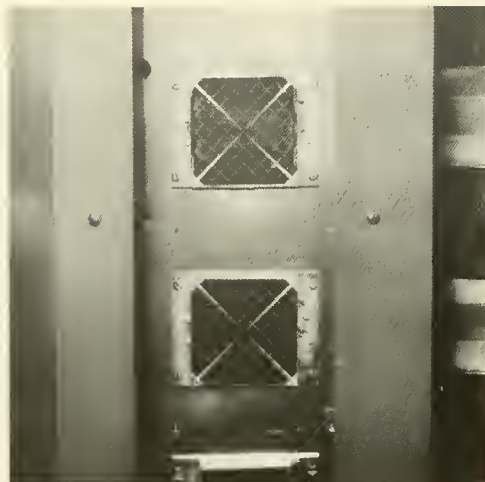
Figure 446
Photo No.: KSC-390C-1835.02
Dup. Neg. No.: L91-10633
LISAR No.: EL-1994-00398
Photo Credit: KSC
Photo Date: 3/12/90
Location: KSC SAEF II
Subject: Postflight Detail of Fifth Row of Tray E9

Figure 446 (Postflight). This close-up photograph is of the fifth row. There appears to be no physical damage, but some brown discoloration around the edges of the solar cells is evident.

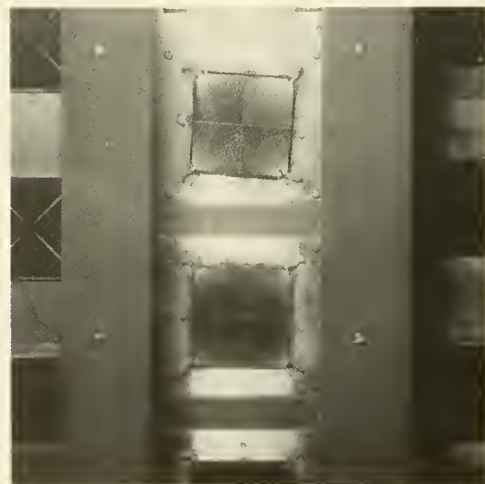
Figure 447
Photo No.: KSC-390C-1835.05
Dup. Neg. No.: L91-10636
LISAR No.: EL-1994-00399
Photo Credit: KSC
Photo Date: 3/12/90
Location: KSC SAEF II
Subject: Postflight Detail of Sixth Row of Tray E9

Figure 447 (Postflight). This close-up photograph is of the sixth row. There appears to be no physical damage, but some brown discoloration around the edges of the solar cells is evident.

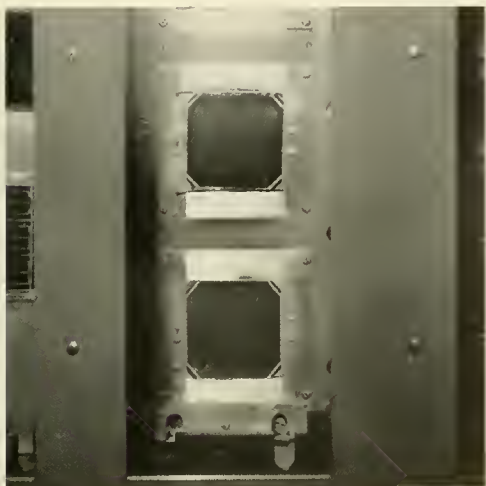
Figure 448 (Postflight). This close-up photograph is of the seventh row. There appears to be no physical damage, but some brown discoloration around the edges of the solar cells is evident.

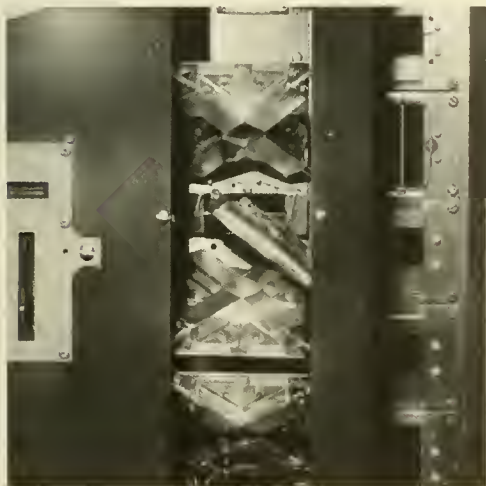
Figure 449 (Postflight). This close-up is of the ninth row. A solar concentrator cell, located at the lower end of the slot, appears to be damaged. The large piece of gold-colored material lodged in the slot appears to be a segment of the aluminum deposited on the Kapton mirror.

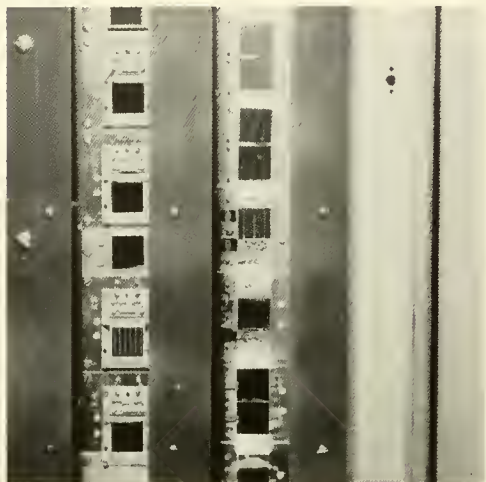
Figure 450 (Postflight). This close-up photograph is of the tenth row. There appears to be no physical damage, but the cell mounting frames have a mottled brown discoloration.

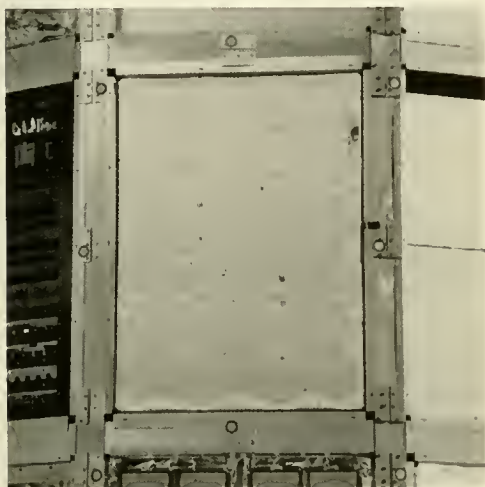
Figure 451 (In Flight). The surface of the thermal cover appears to have changed from specular to opaque with numerous black dots of various sizes, thus indicating impacts or penetrations. The cover is taut and the locations of Velcro attachment pads are prominent. The ground strap has no visible damage, but is a deeper copper color.

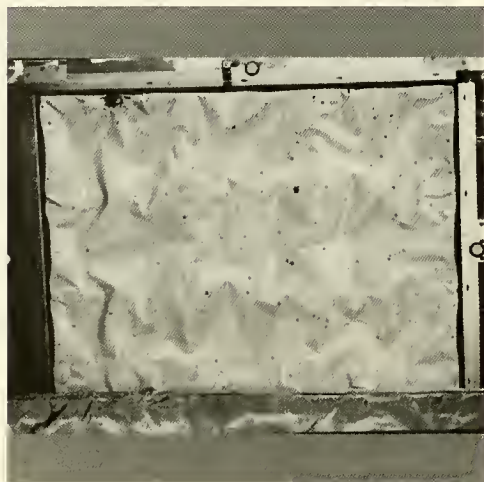
Figure 452 (Postflight). The surface of the thermal cover appears to have changed from specular to opaque with numerous black dots of various sizes, thus indicating space debris impacts or penetrations. The cover is less taut than in flight. The locations of Velcro attachment pads are visible. The pinkish green tint on the thermal cover is caused by the lighting and reflections from the surroundings. The arm of the RMS that is cradled in the Shuttle is visible at the bottom.

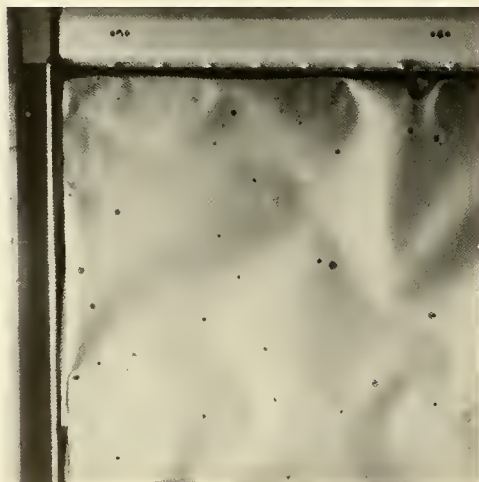
Figure 453 (Postflight). This photograph is of the upper left one-sixth of the tray. The thermal cover is now opaque and not as highly reflective as it was in the preflight photograph. There are numerous black dots of various sizes that indicate space debris impacts or penetrations. The thermal cover Velcro attachment pads are evident.

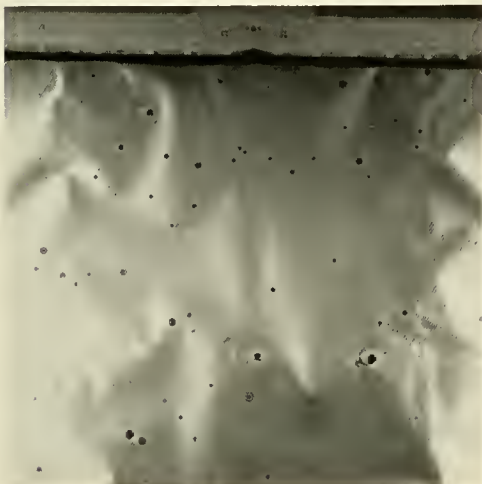
Figure 454 (Postflight). This photograph is of the upper center one-sixth of the tray. The thermal cover is now opaque and not as highly reflective as it was in the preflight photograph. There are numerous black dots of various sizes that indicate space debris impacts or penetrations. The thermal cover Velcro attachment pads are evident.

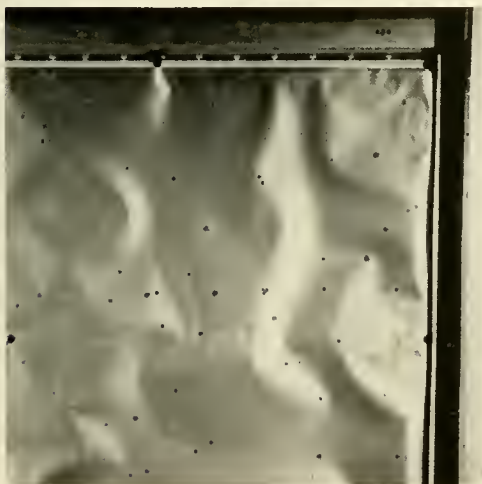
Figure 455 (Postflight). This photograph is of the upper right one-sixth of the tray. The thermal cover is now opaque and not as highly reflective as it was in the preflight photograph. There are numerous black dots of various sizes that indicate space debris impacts or penetrations. The thermal cover Velcro attachment pads are evident.

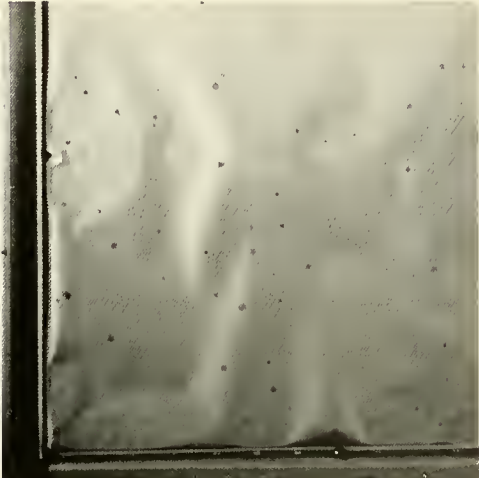
Figure 456 (Postflight). This photograph is of the lower left one-sixth of the tray. The thermal cover is now opaque and not as highly reflective as it was in the preflight photograph. There are numerous black dots of various sizes that indicate space debris impacts or penetrations. The thermal cover Velcro attachment pads are evident.

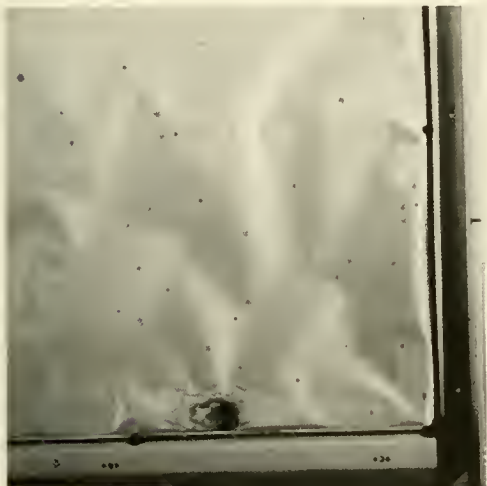
Figure 458 (Postflight). This photograph is of the lower right one-sixth of the tray. The thermal cover is now opaque and not as highly reflective as it was in the preflight photograph. There are numerous black dots of various sizes that indicate space debris impacts or penetrations. The thermal cover Velcro attachment pads are evident.

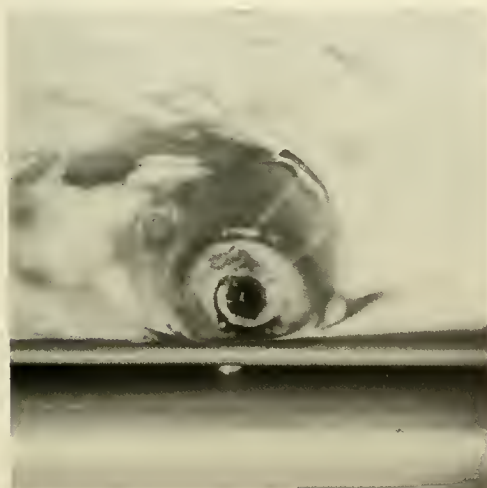
Figure 459 (Postflight). This close-up photograph is of the large discolored area at the edge of the thermal cover near the lower right corner of the tray.

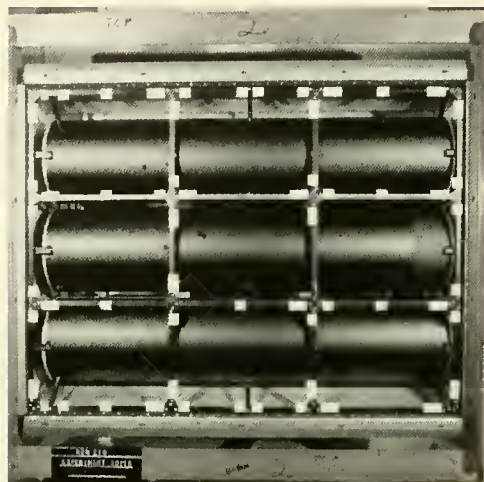
Figure 460 (Postflight). This photograph is of tray E10 after the thermal cover has been removed. Note the spots visible on the upper cylinders. These discolorations occurred behind penetrations of the thermal cover. The frame with the Velcro pads for attaching the thermal cover is visible.

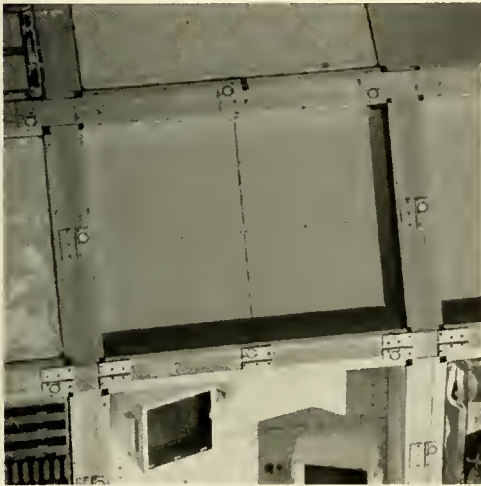
Figure 461 (In Flight). A portion of the pink and greenish-gray tint on the two debris panels is a by-product of the chromic anodize coating process; however, part of the intensity can be attributed to reflections of the blue sky. The vertical streaks on the debris panel are by-products of chromic anodizing that have been enhanced by the blue reflection. The light band along the vertical edge of the left debris panel is a reflection from the tray sidewall.

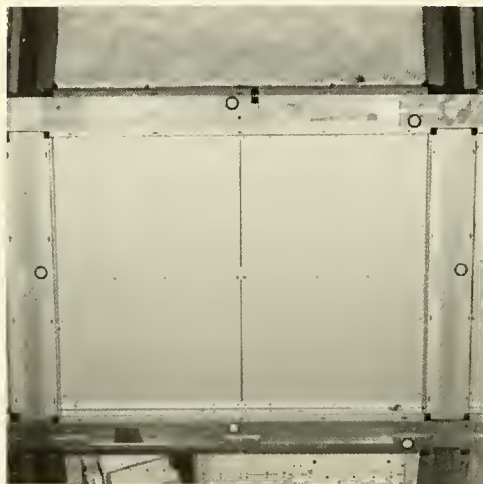
Figure 462 (Postflight). The pink and greenish-gray tints on the two debris panels are by-products of the chromic anodize coating process and are not attributed to contamination or exposure to the space environment. The vertical streaks observed on the debris panels in the in-flight photograph are no longer visible because the reflection of the sky is not present. Debris from other experiments that were significantly degraded during the mission are visible on the lower experiment tray sidewall at the intersection with the lower edge of the debris panels. Other experiment debris, visible as dark specks, are at the intersection of the debris panel outer edges and the tray sidewalls. The light band along the sides and across the bottom of the panels is caused by light reflecting from the tray sidewalls.

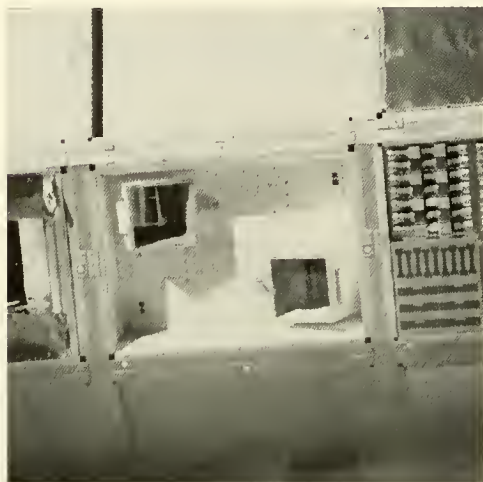
Figure 464 (In Flight). The color of the thermal control paint on experiment AO038 has changed and now varies from white to shades of brown. The shadows from the tray sidewalls hide most of the dark stain in the upper right corner of the tray.

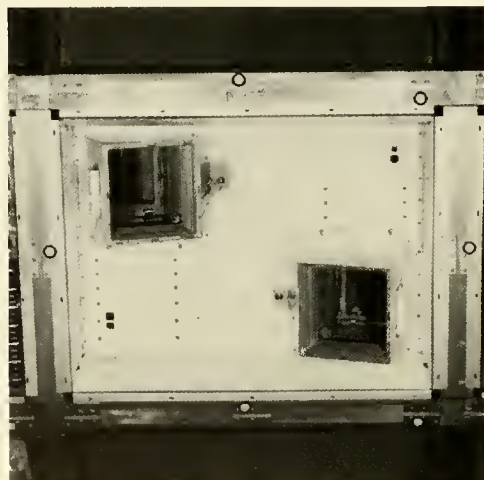
Figure 465 (Postflight). Brown stains are prominent, especially around the openings in the baseplate for the grid voltage cable connectors. The beryllium copper collector foils are clearly visible in this photograph, as are the baffles near the top of the canister housing. However, the fine wire mesh grid is not visible. Because of an experiment system malfunction, the canister collector foils that are visible were exposed for the total mission.

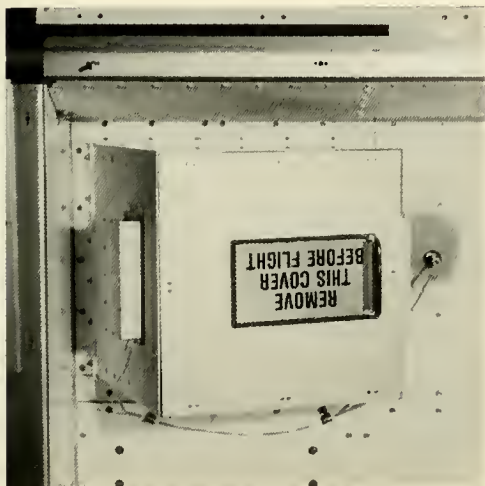
Figure 466 (Postflight). This photograph is of the upper left one-sixth of the tray. Note the brown discoloration in the tray corner and around the grid voltage plug to the right of the canister. The cover was installed on the canister housing to protect the space-exposed hardware.

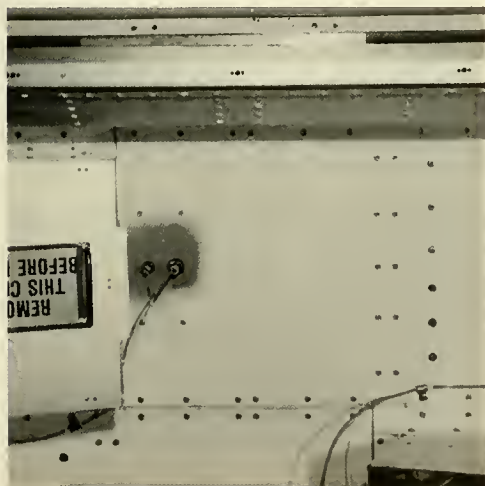
Figure 467 (Postflight). This photograph is of the upper center one-sixth of the tray. Note the brown discoloration around the grid voltage plug to the right of the canister. The cover was installed on the canister housing to protect the space-exposed hardware.

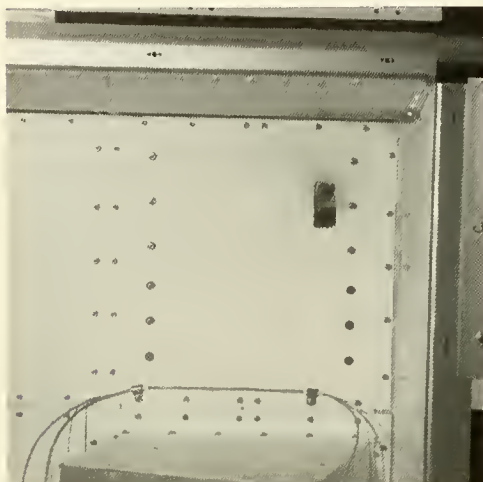
Figure 468 (Postflight). This photograph is of the upper right one-sixth of the tray. Note the light brown discoloration in the tray corner.

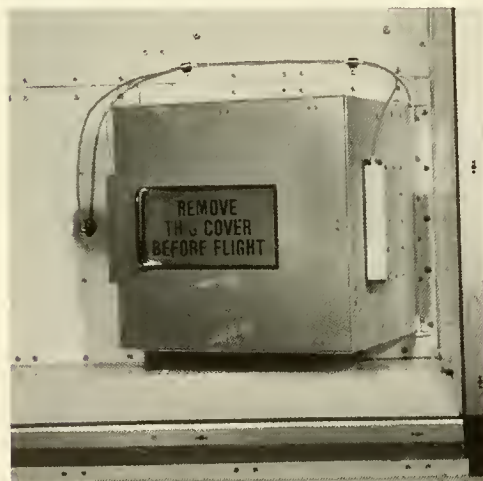
Figure 469 (Postflight). This photograph is of the lower right one-sixth of the tray. Note the brown discoloration around the grid voltage plug to the left of the canister. The cover was installed on the canister housing to protect the space-exposed hardware.

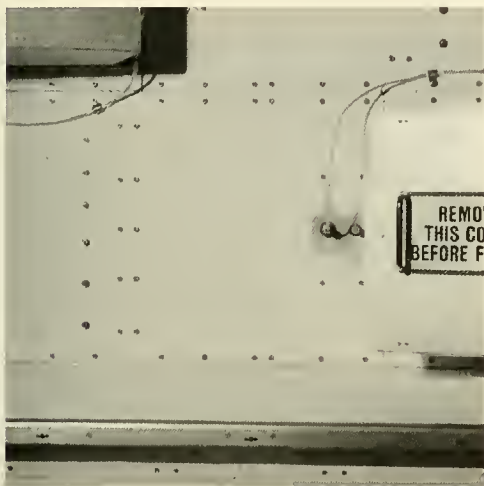
Figure 470 (Postflight). This photograph is of the lower center one-sixth of the tray. Note the brown discoloration around the grid voltage plug to the left of the canister. The cover was installed on the canister housing to protect the space-exposed hardware.

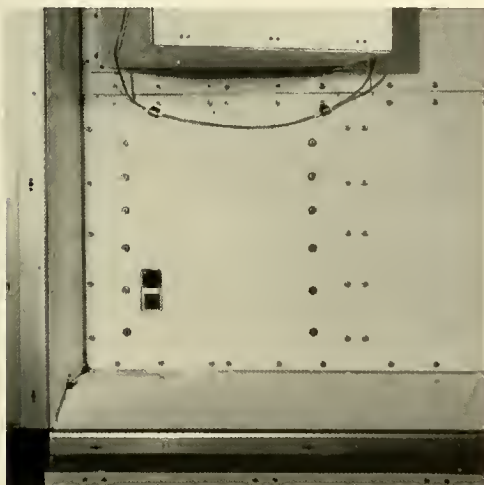
Figure 471 (Postflight). This photograph is of the lower left one-sixth of the tray. There is little, if any, discoloration present.

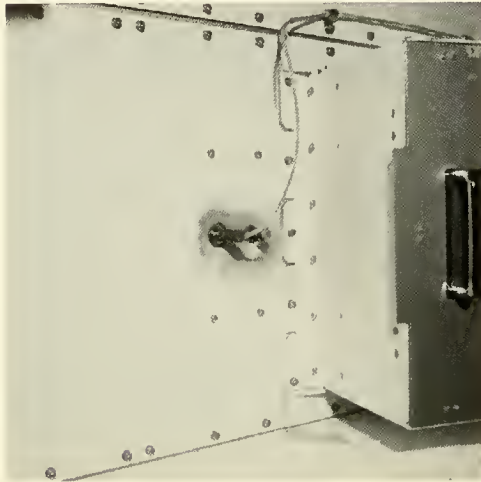
Figure 472 (Postflight). This close-up photograph is of the lower right corner canister. Note the discoloration around the grid voltage plug and the well-defined discoloration pattern on the tray wall.

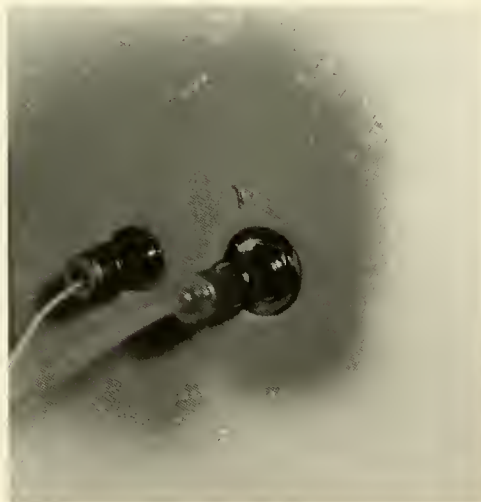
Figure 473 (Postflight). This close-up photograph is of the grid voltage plug that was located to the right of the upper left canister. Note the dark discoloration and the small piece of debris from one of the other experiments.

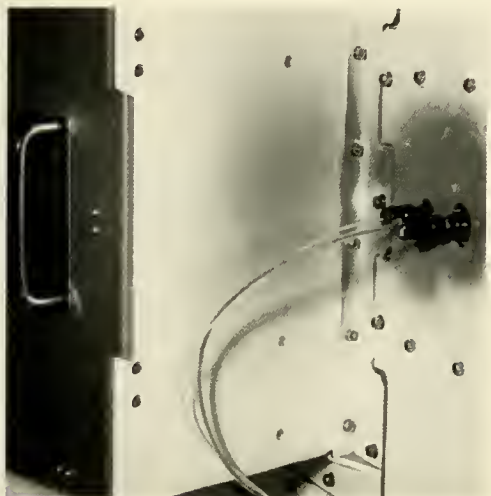
Figure 474 (Postflight). This close-up photograph is of the grid voltage plug that was located to the right of the upper left canister. Note the discolored area around the plug and the discoloration pattern on the canister wall.
